EZDown Reloaded Instruction - 1st Fitment

EZDown Reloaded Ford - RL0590

EZDown Reloaded Instruction - 2nd Fitment

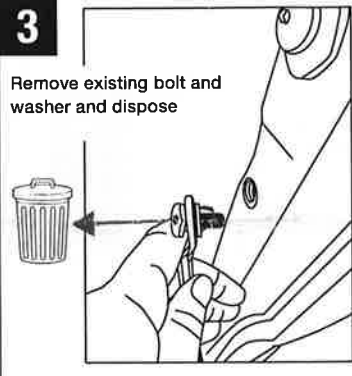
16 Confirm that the Damper has some movement in the tailgate open position therefore ensuring the cables are taking the tailgate weight and not the damper.
