EZDown Reloaded Instruction
- 1st Fitment

EZDown Reloaded NISSAN NAVARA RL0750

**EZDown Reloaded Instruction
- 2nd Fitment**

EZDown Reloaded NISSAN NAVARA - RL0750

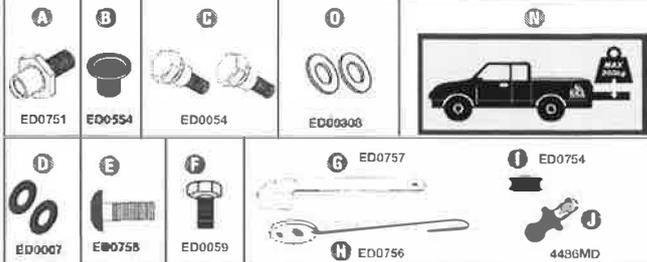
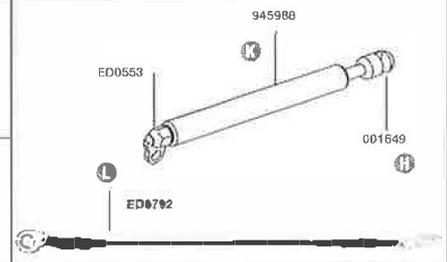
1
RHS and LHS are determined when sitting in the Drivers side of the Vehicle.

Note: We recommend you use a Rust inhibitor where you drill as well as locktite bolts were necessary.

Fit kit on RHS only
